## 4.0 INDUSTRIAL BUILDING DEMOLITION

#### 4.1.3 Industrial Building Demolition

## **5.0 EMERGENCY RESPONSE AND POLE MOUNTED TRANSFORMER REMOVAL**

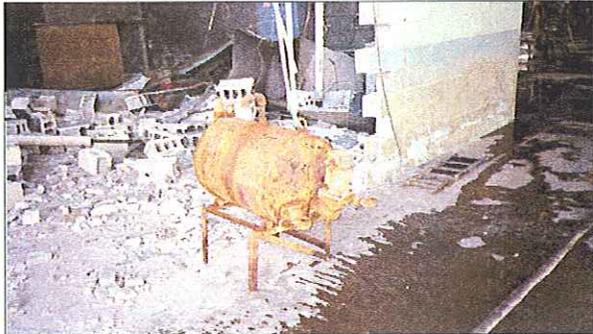
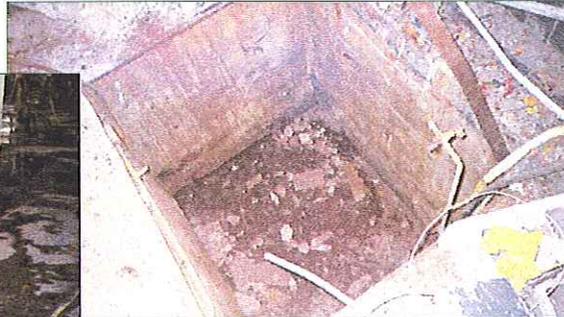
Approximately 50 gallons of residual fuel were encountered in the 200 gallon diesel fuel AST. The fuel was transferred into a 50-gallon DOT-approved drum and sent to a fuels blending/recycling facility. The remaining two tanks were empty. Each tank was subsequently cleaned, purged of all flammable vapors, and cut to insure they will not be resold or reused. Once the tanks were removed, the concrete secondary containment was demolished to a minimum of two feet below grade. Soil at the base of the tank containment area was screened using a photoionization detector (PID) by the MWH site superintendent. Soils were screened from each edge and the center of the pad area. No recordable levels were present when screened with the PID.

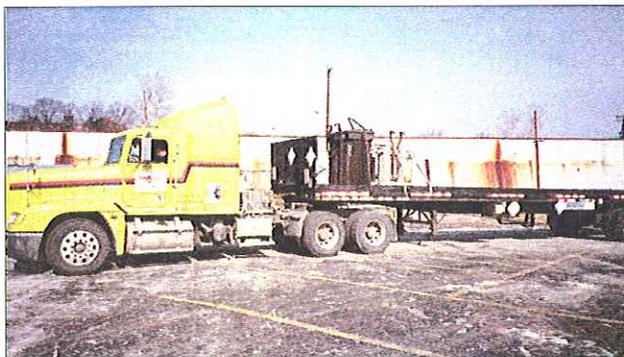
As stated previously, sampling and testing of the pad-mounted transformer occurred during the MWH 2002 Remedial Investigation and Feasibility Study. Removal of the pad-mounted transformer was initiated during the asbestos abatement project. On December 10, 2002 Ameren arrived on site to disconnect all the power and de-energize the main power transformer. It was noted at that time, that the dielectric fluid was leaking from the pad-mounted transformer. Emergency response actions were immediately taken to minimize the release. Subsequently, the transformer fluid was drained into DOT-approved 55-gallon drums. The transformer

carcass was decontaminated for transportation and disposal. On March 11, 2002, the transformer carcass was loaded onto a flat bed truck operated by Clean Harbors for disposal. Waste Disposal Manifests are provided in Appendix F.

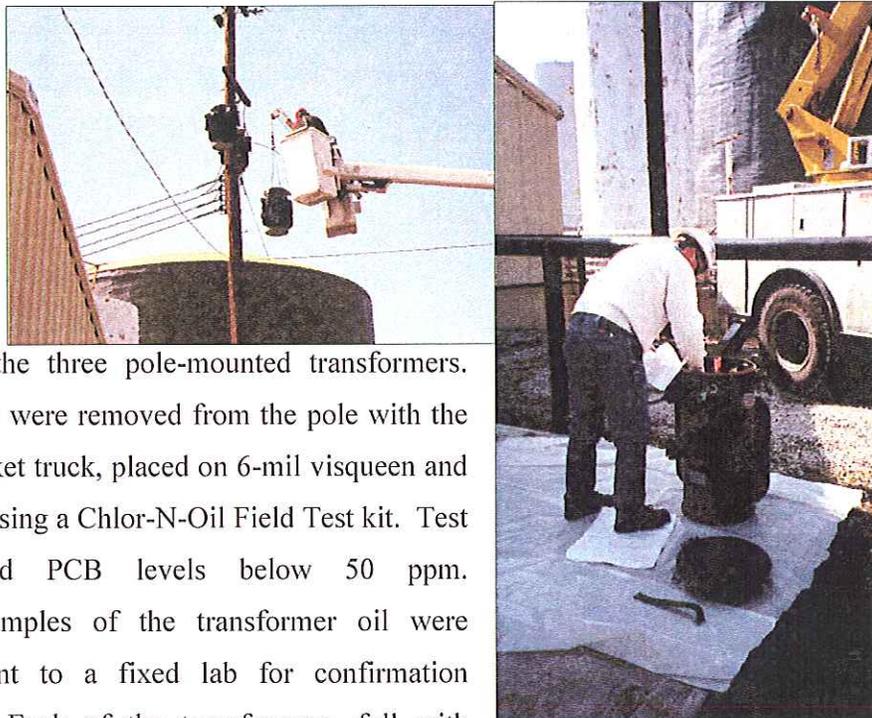
On March 11, 2003, Singley Environmental arrived at the facility to begin removal and testing of the three pole-mounted transformers. The transformers were removed from the pole with the support of a bucket truck, placed on 6-mil visqueen and the oil sampled using a Chlor-N-Oil Field Test kit. Test results indicated PCB levels below 50 ppm. Confirmation samples of the transformer oil were subsequently sent to a fixed lab for confirmation (Appendix F). Each of the transformers, full with

dielectric fluid, were loaded onto a truck for transportation and disposal to the Clean Harbor facility located in Coffeyville, Kansas. Copies of the transportation and disposal manifests are provided in appendix F.

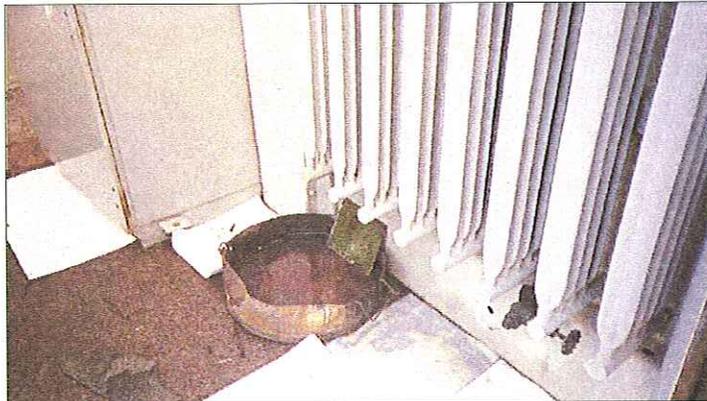
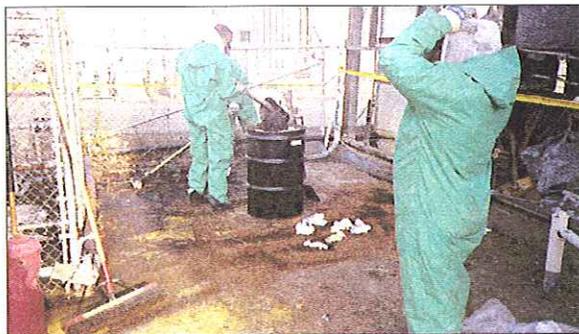
As previously noted in Section 5.1, a release of dielectric fluid from the pad-mounted transformer was discovered on December 10, 2002. Immediately upon discovery, MWH personnel took measures to minimize the release. USCG personnel were notified and the source of the leak contained. The affected area included the concrete slab where the transformer resided and surrounding soils.

MWH was authorized to proceed with emergency response procedures. Absorbent materials were placed over the concrete and affected soil area. The absorbent and surficially impacted materials were placed in DOT approved containers and stored on site. Work progressed into the night until all the surficial material had been contained.

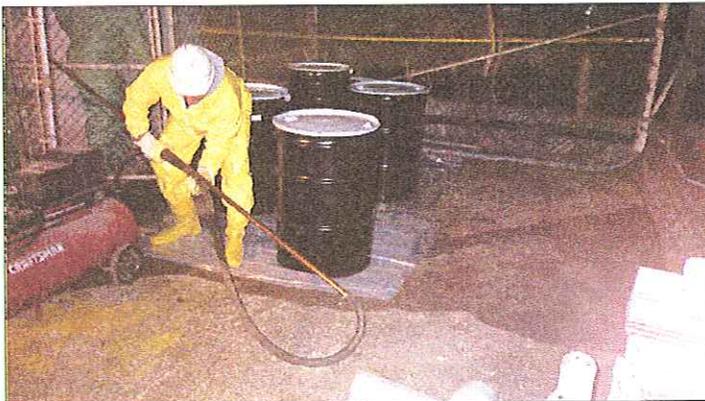
Subsequent action included the excavation and removal of the concrete slab and affected soil contamination. During this effort approximately 20 tons of material was excavated and placed in roll-off
