June 11, 2007

06-23774-01

USFS Region 4
Humboldt Toiyabe National Forest
1200 Franklin Way
Sparks, Nevada 89431

Subject: Lead-Based Paint Risk Assessment Report
Addendum #1
Sandia Housing #17
Tonopah, Nevada

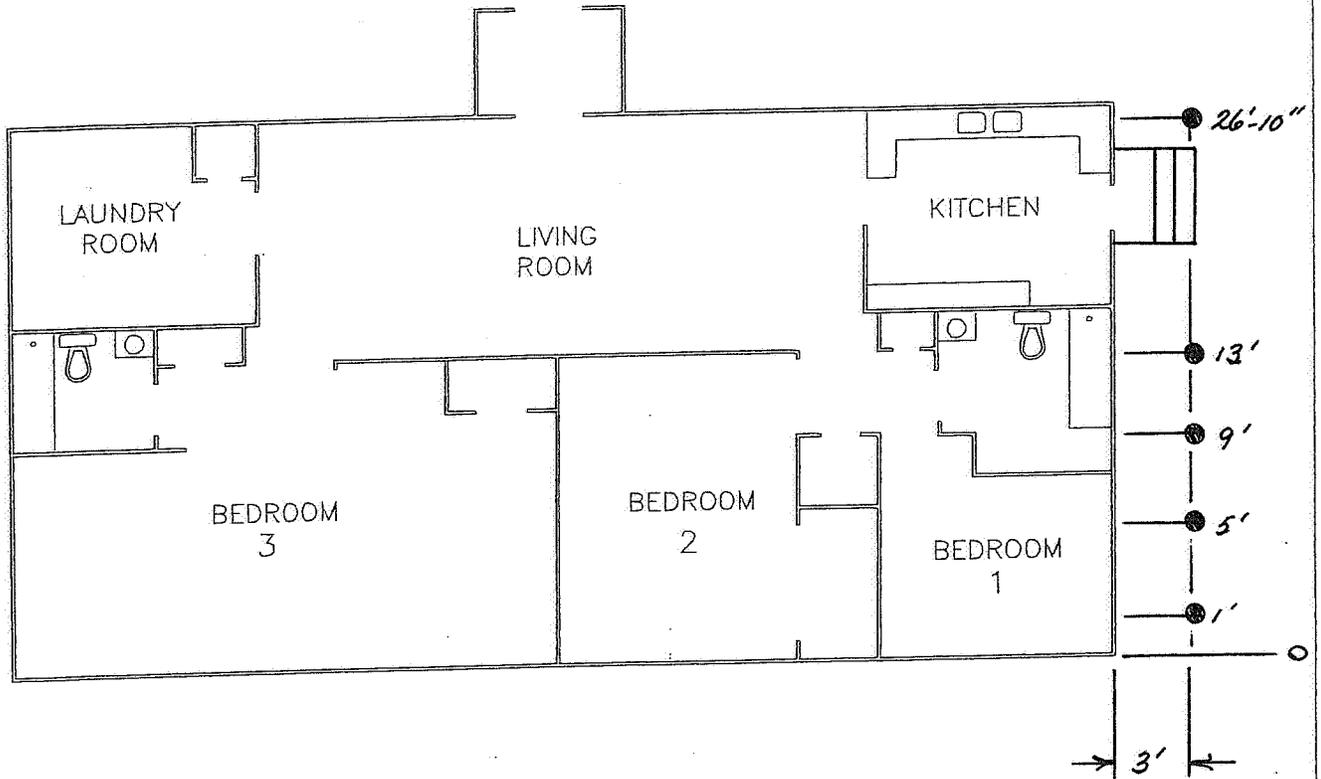
S-01
5 ALIQUOTS TOP 1/2" SOIL

EAST COMPOSITE

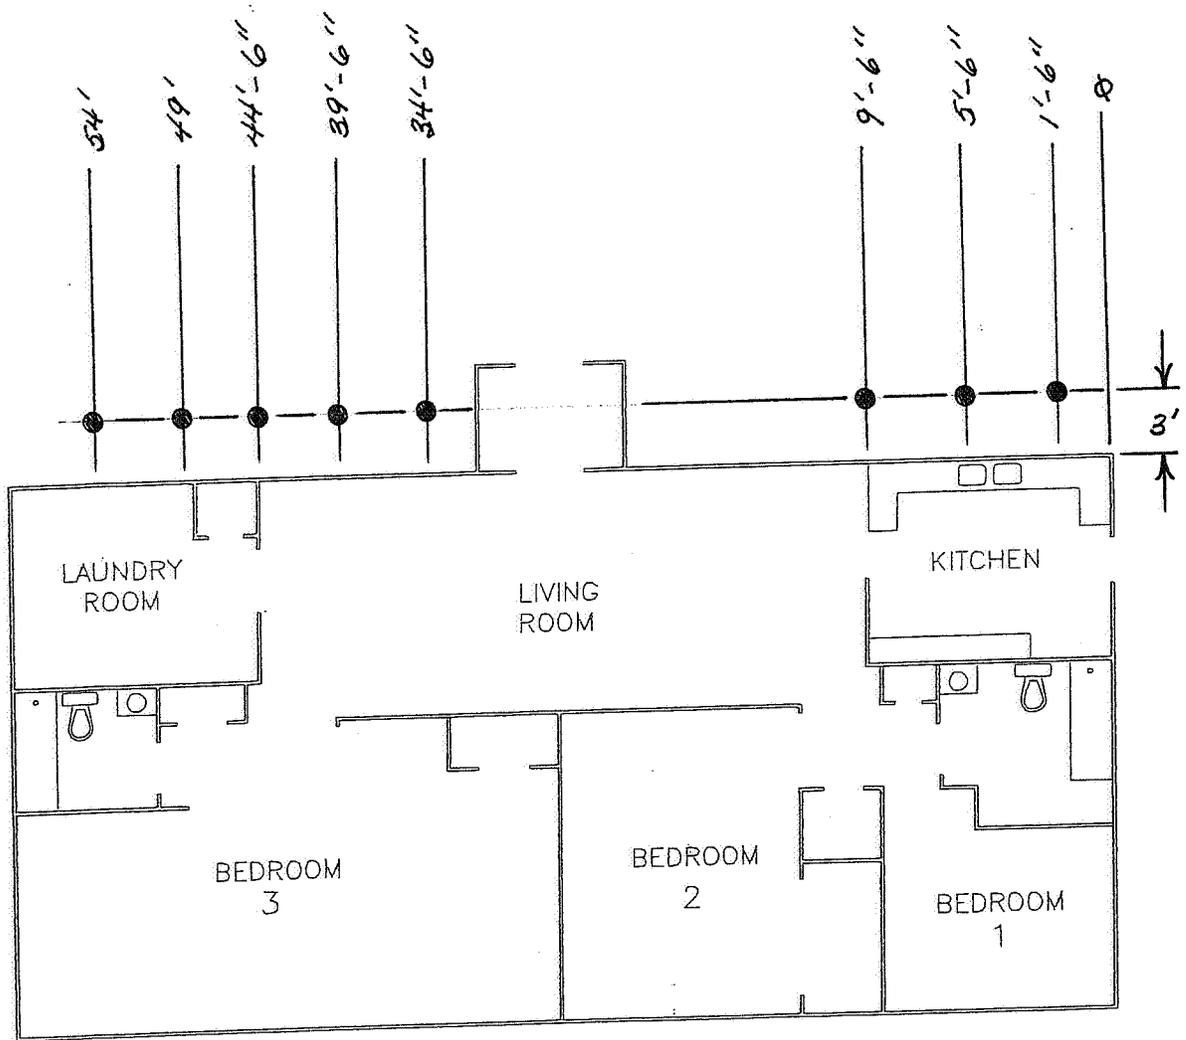
S-02
 8 ALIQUOTS TOP 1/2" SOIL

North Composite

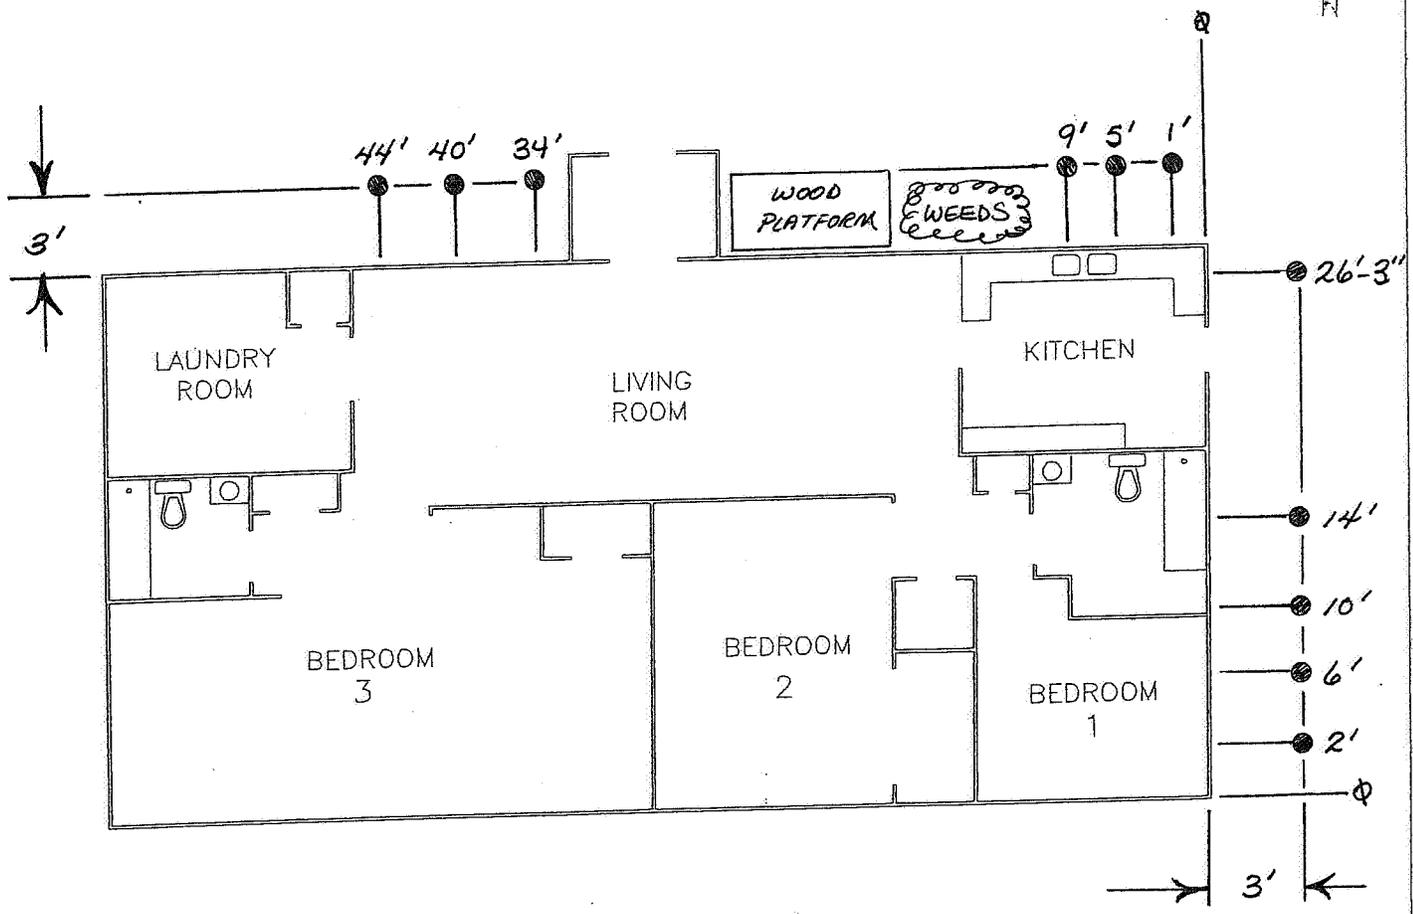
S-03

11 ALIQUOTS TOP 1/2" SOIL
