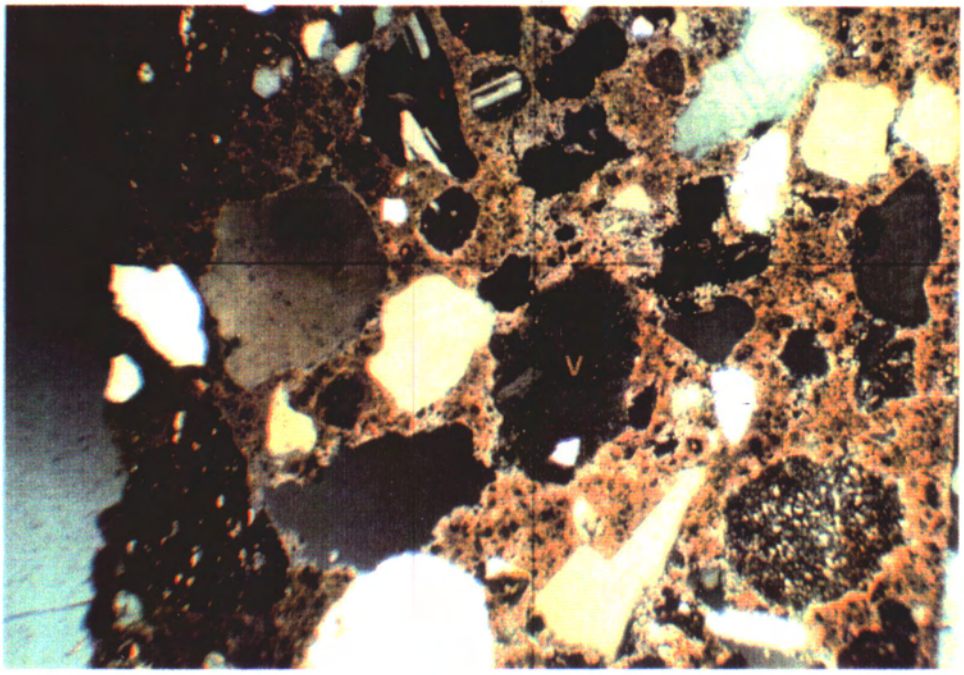
Photo #1. Core #16 Photomicrograph of extremely carbonated matrix (light colored, mottled, high birefringence). Outside surface of core on the left.
40X, XP, surface

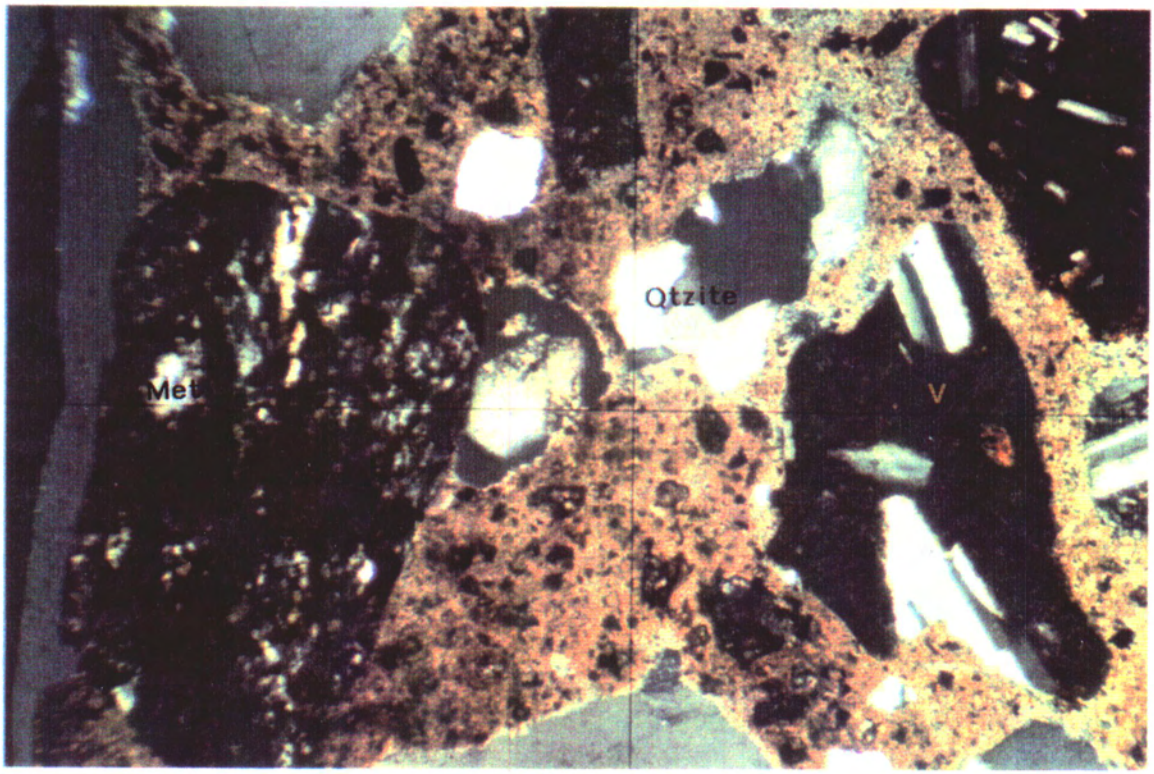
Photo #2. Core #16 This is an enlargement of the upper left corner of Photo #1, showing the total carbonation of the matrix and carbonate dissolution of the edges of the quartz grain between the metamorphic and quartzite grains
100, XP, surface

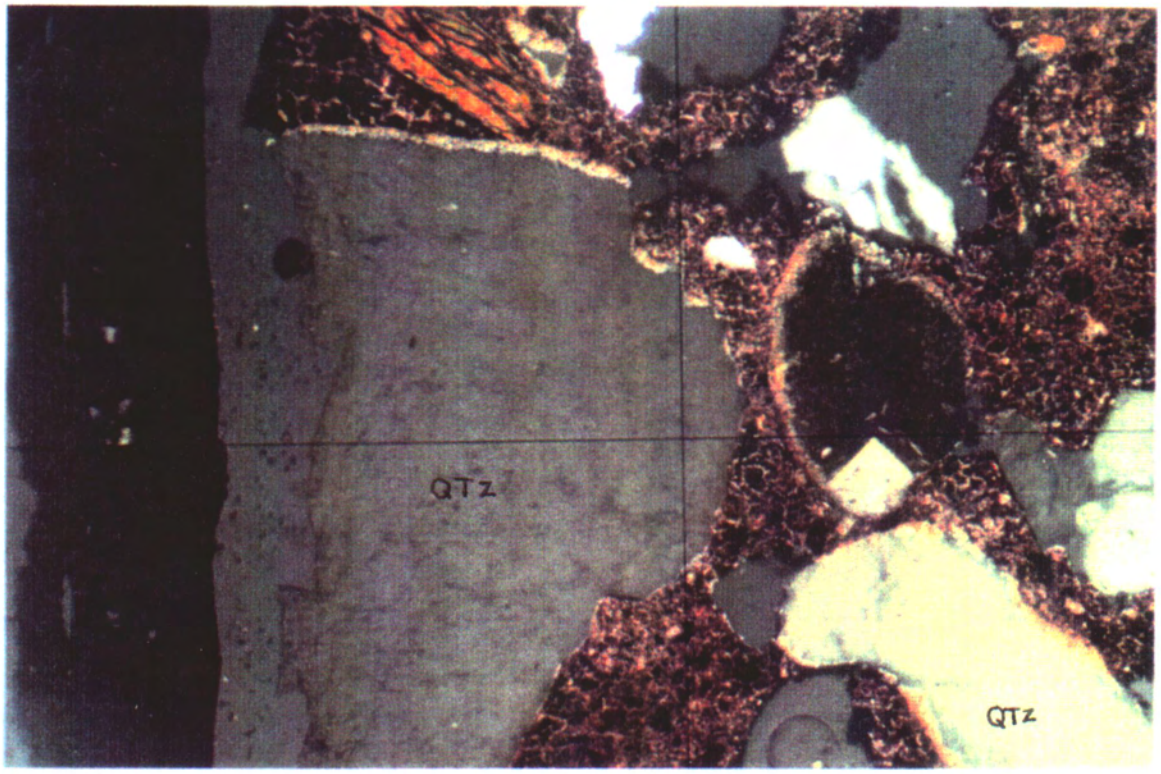
Photo #3. Core #16 Photomicrograph of quartz grains with bright alkali-silica reaction rims along some edges. The red matrix is carbonated but it is obscured by a calcite dye used to identify carbonates.
100X, XP, surface

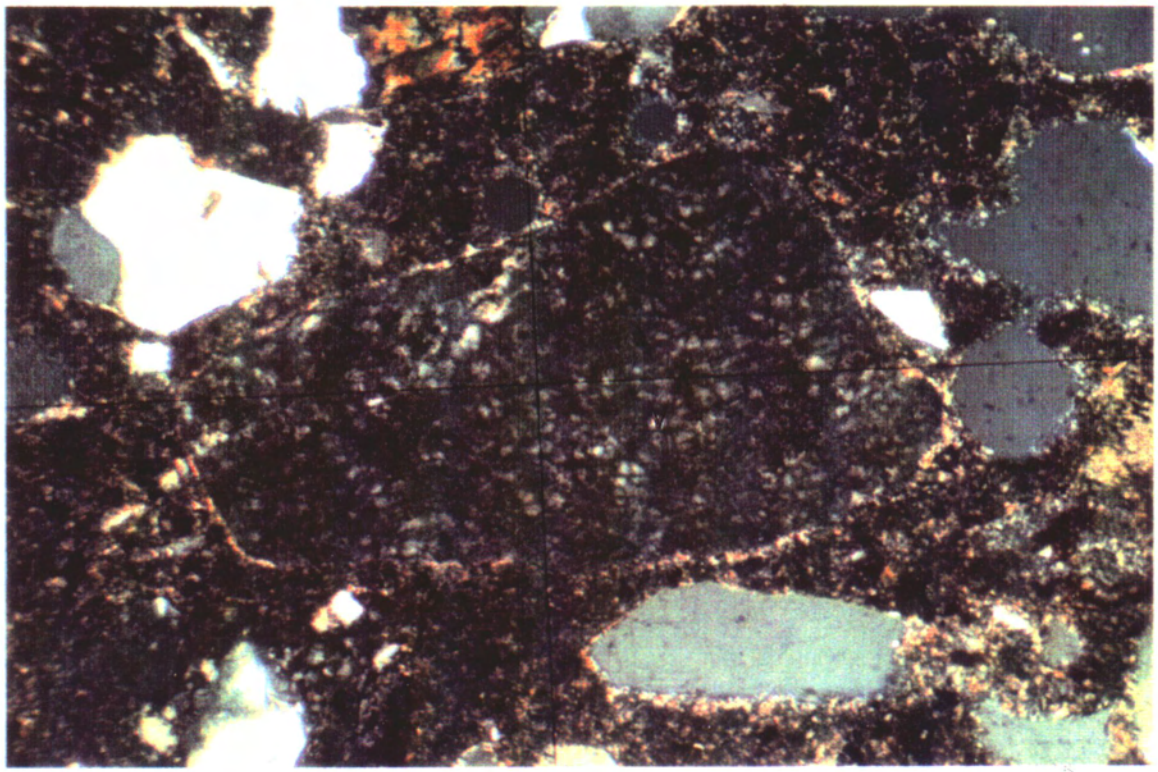
Photo #4. Core #16 Volcanic grain in the center is outlined by an irregular reaction rim of carbonate. Matrix is lightly carbonated.
100X, Xp, 5/8" depth

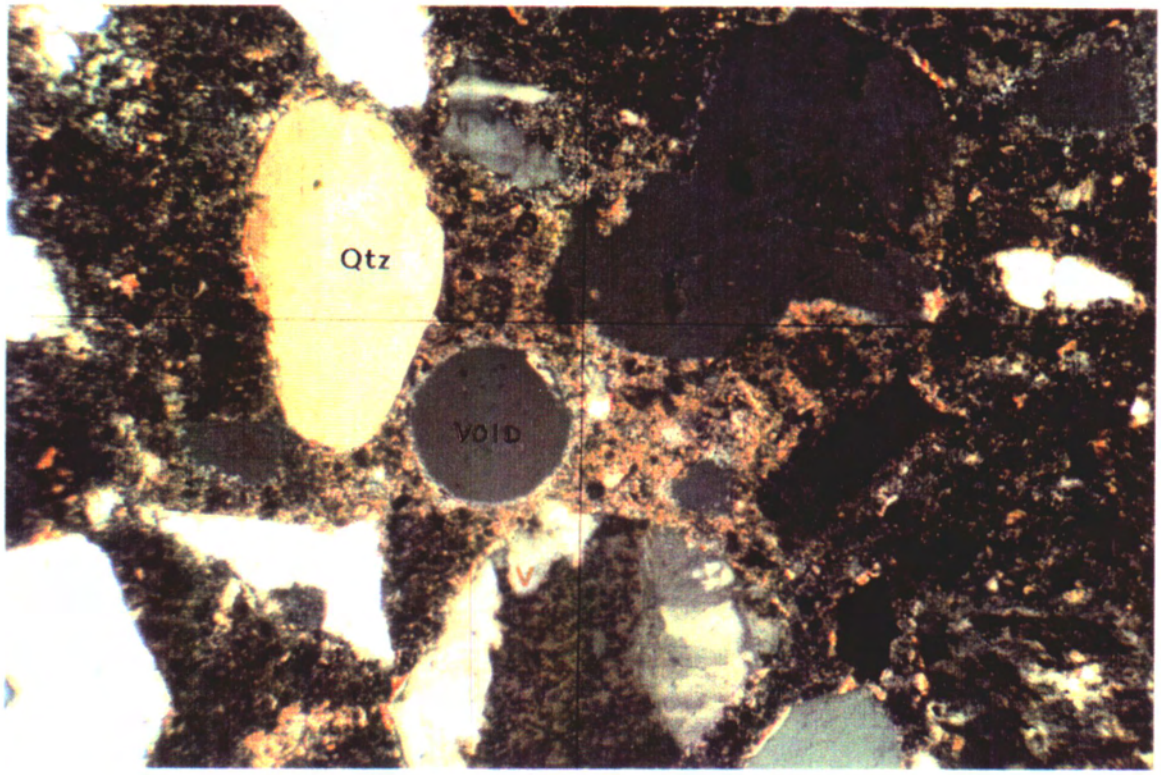
Photo #5. Core #16 Highly carbonated matrix patch around an air void in the center.
40X, XP, 1 1/4" depth

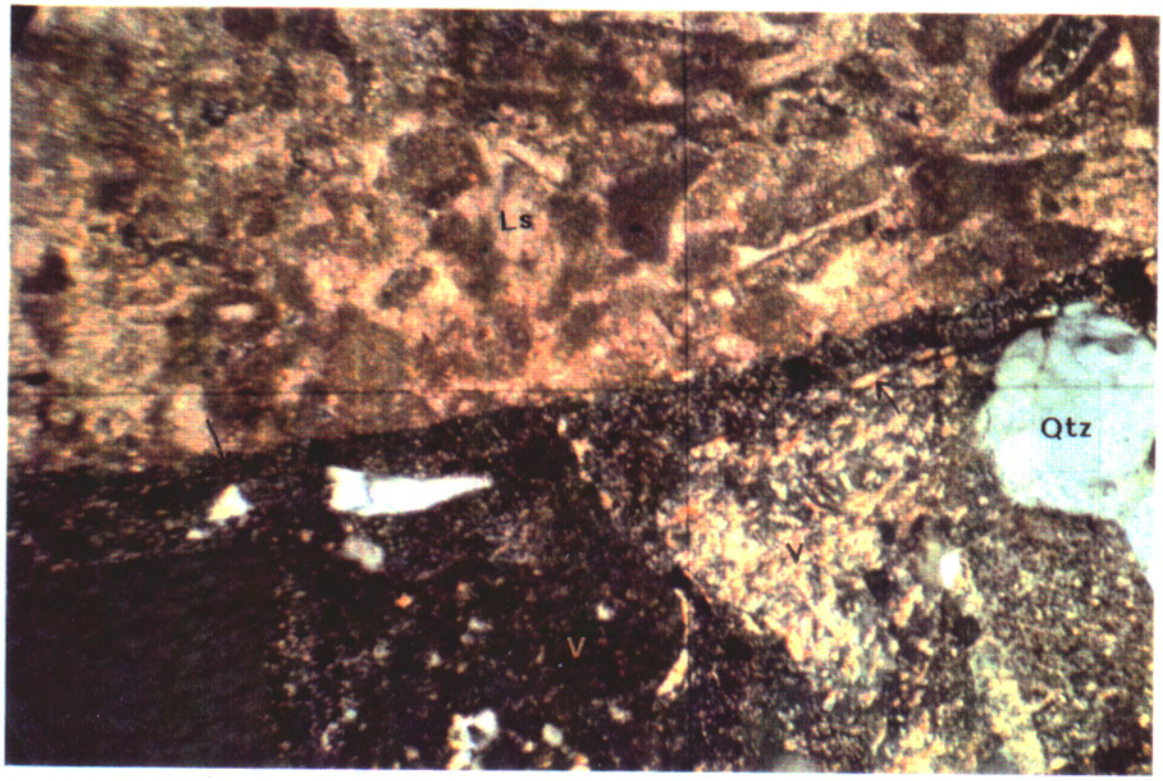
Photo #6. Core #16 A small crack extends along the lower edge of the large limestone aggregate at the top of the photo. The crack actually is in the volcanic and quartz grains at center right edge and is probably due to alkali-aggregate reaction.
100X, XP, 1 3/8" depth

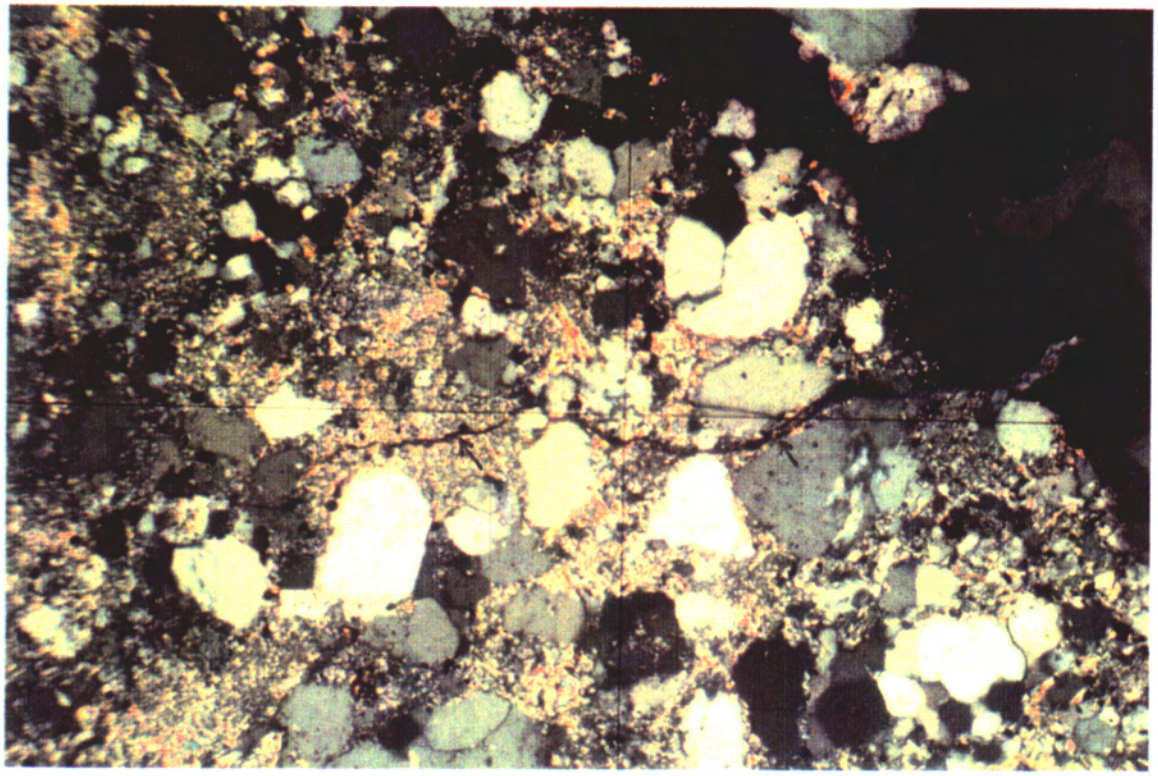
Photo #7. Core #16 Crack in calcarous quartzite particle (left) extending into cement paste (right). Some Alkali-silica reaction gel has been extruded into matrix crack.
40X, XP, 1 3/8" depth

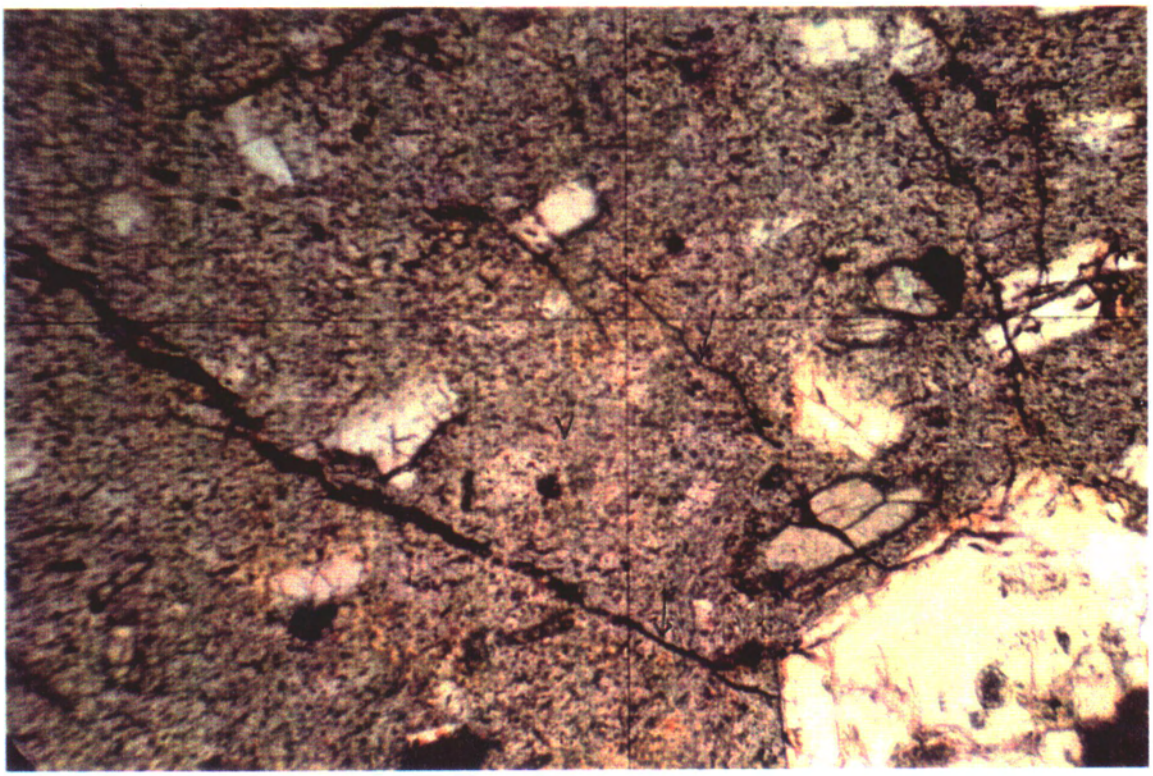
Photo #8. Core #16 Alkali-silica reaction cracks in a volcanic porphyry aggregate.
100X, PL, 2 3/4" depth

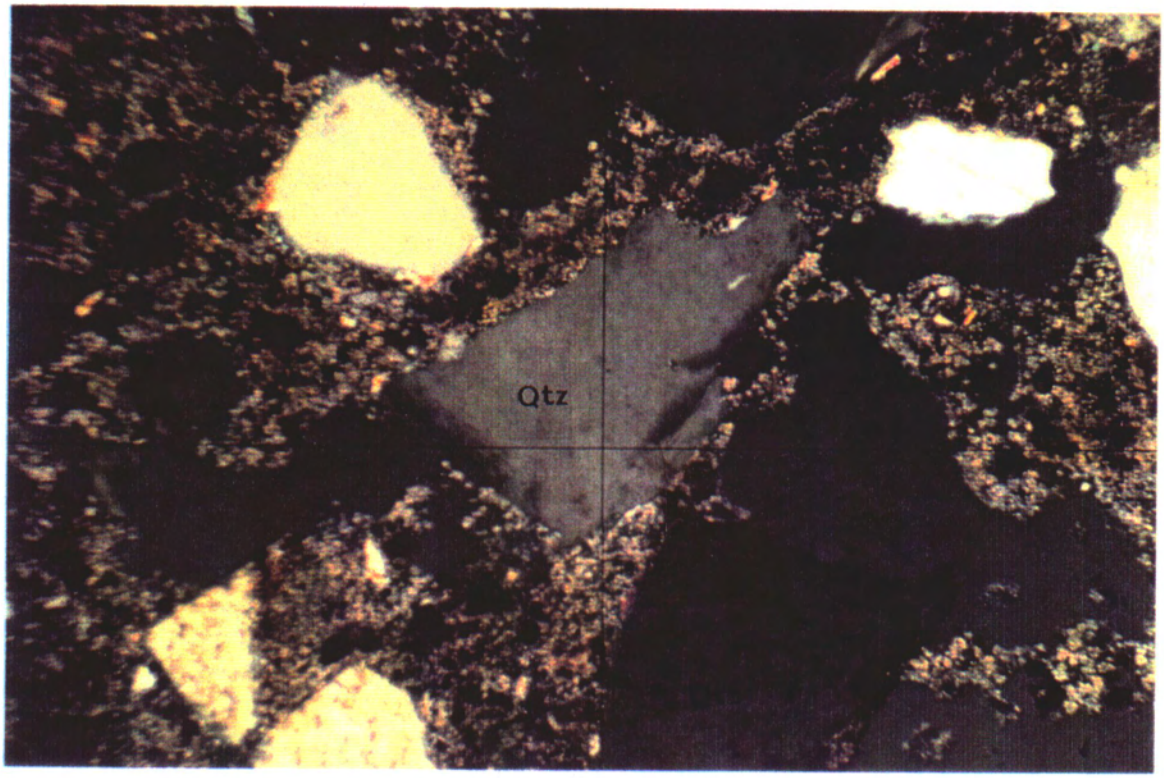
Photo #9. Core #16 Photo illustrates the plucking and removal of matrix by thin section preparation. The softened carbonated matrix tended to be removed during normal grinding.
100X, XP, 2 1/4" depth

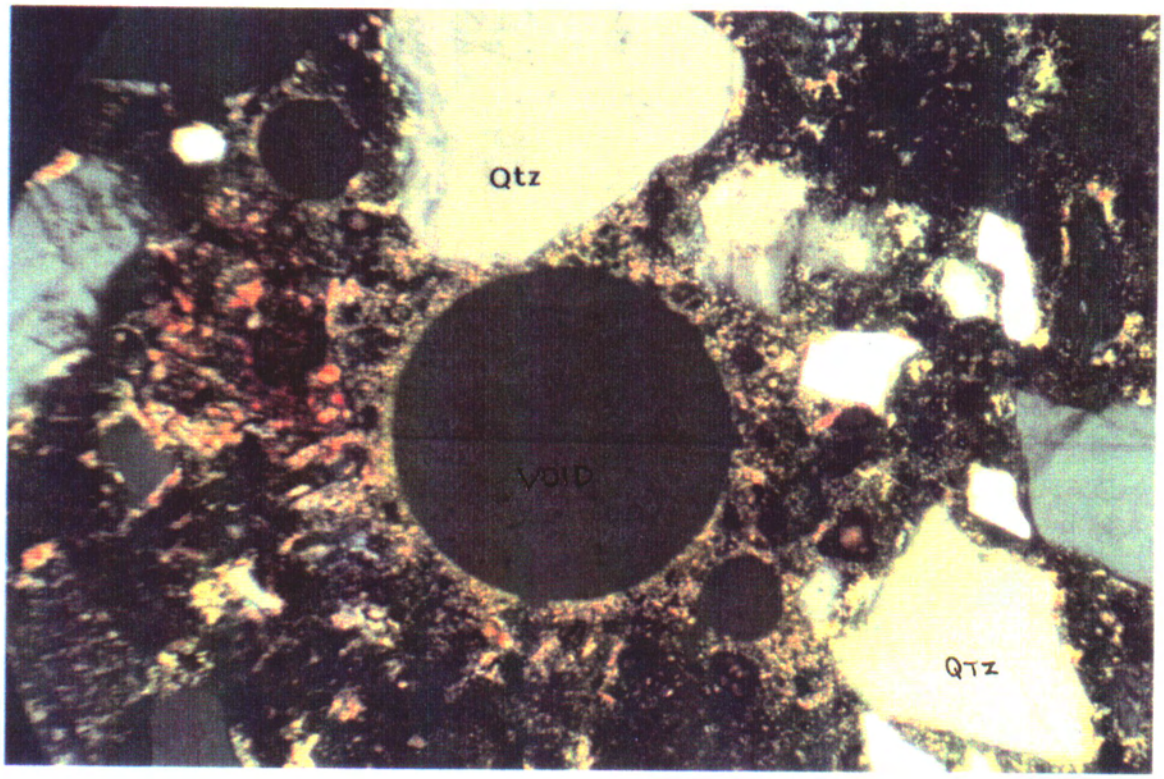
Photo #10. Core #16 Three air voids are surrounded by carbonated rims and most of the grains also have rims of carbonated paste.
40X,XP, 1 5/8 depth
